DIVISION OF INSPECTOR GENERAL
Ken Burke, CPA
Clerk of the Circuit Court and Comptroller
Pinellas County, Florida

AUDIT OF PINELLAS COUNTY CAPITAL IMPROVEMENT PROGRAM AND INFRASTRUCTURE - UTILITIES

**REPORT NO. 2018-11
MAY 24, 2018**

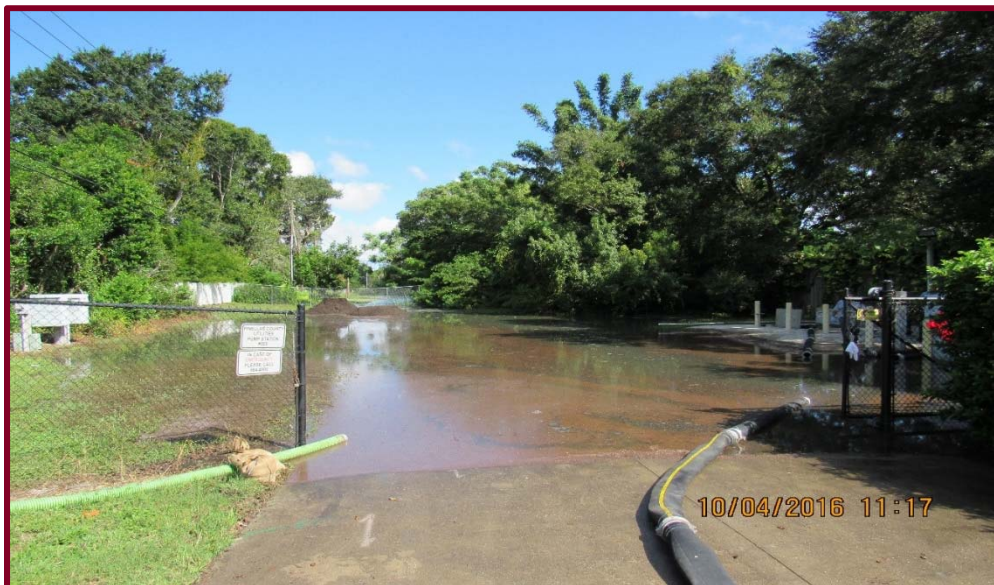
An example of a costly, unplanned failure occurred on October 4, 2016, when a 30-inch sewer line broke in the Palm Harbor area. We toured the area of the break, located on Alderman Road and Omaha Street, on October 4, 2016 at approximately 10:30 am. Utilities and contractor crews

were already on-site responding to the issue. We observed that the sewer line break caused sewage to spill out in the retention pond, almost to the sidewalk by the Utilities pumping station. The smell emerging from the break was very toxic; in addition, there was heavily soiled greenery by the street.

Management stated the break was a result of several factors, which included the age of the pipe, air release valves (ARVs) not opened due to odor issues from years past (it was an administrative decision at that time), as well as the set-up of the pipes that created unnecessary gasses to build up, which eroded the pipes faster than expected.

An Asset Management Program can help Utilities meet the challenges of financing capital improvements, and renewing and replacing aging infrastructure. The Asset Management Program is the foundation for the development of Master Plans. See OFI No. 2 for further discussion.

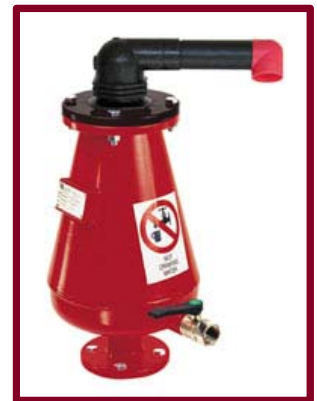
ARVs are hydromechanical devices designed to automatically release air and wastewater gases or admit air during the filling, draining, or operating of liquid piping systems for water and wastewater services. As air and gas pockets form in the sewer pipes, it is important to have functioning valves to release these gases to help prevent corrosion, burst pipes, as well as reduced sewer flow.

Due to a lack of dedicated employees to maintain the sewer ARVs, many PM work orders have gone uncompleted for several years. The lack of maintaining or inspecting sewer ARVs on a regular basis could result in a shorter life for the valves, as well as shortening the life of the sewer pipes and pumps due to failing valves not allowing corrosive gases to be released from the pipes.

Per PM best practices set forth by Pinellas County Utilities, as well as best practices and maintenance programs from similar counties across the country, sewer ARVs should be inspected and cleaned on an annual basis to ensure valves operate as intended, as well as to extend the life of the valves themselves and the sewer pipes they service.

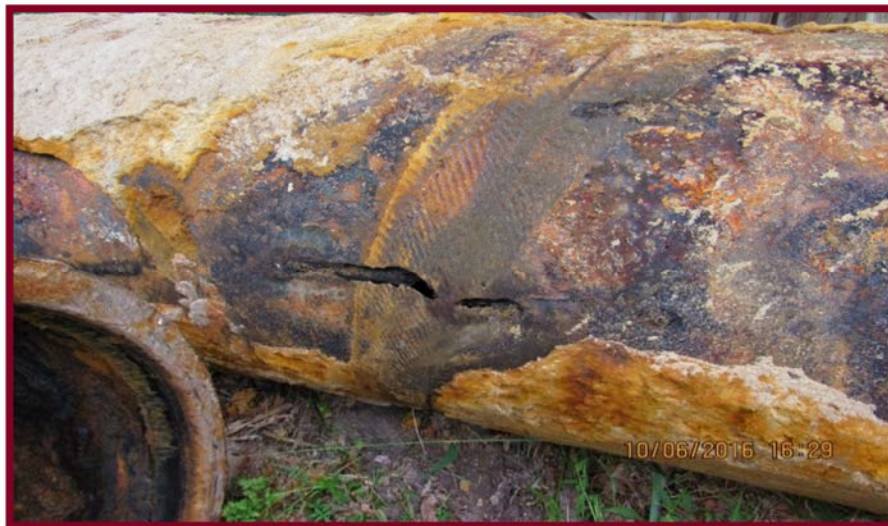
Additionally, in certain parts of the County, at the request of citizens and the discretion of Management, ARVs were closed to eliminate the foul odor from the gases they are intended to release. On October 4, 2016, a 30-inch sewer force main in Palm Harbor broke, spilling an unknown amount of raw sewage into a nearby retention pond at approximately 1,000 gallons per minute. Initial review by Utilities Engineering and Management suspected the pipe failed due to its age of almost 40 years old; however, further investigation determined the ARVs on that pipe segment were closed years earlier after several complaints from nearby citizens regarding the odor. Closing the air valves trapped corrosive gases, causing the pipe to deteriorate at a faster rate than expected.

The picture below demonstrates the level of deterioration of the sewer force main, which caused the Palm Harbor sewage spill.

As a result of this spill, Management stated they will be changing their method of operations regarding ARVs, including not closing them despite the smell and complaints from citizens.

Starting in 2017, Utilities reviewed and reorganized their PM operations and now have a team solely dedicated for sewer ARV maintenance.

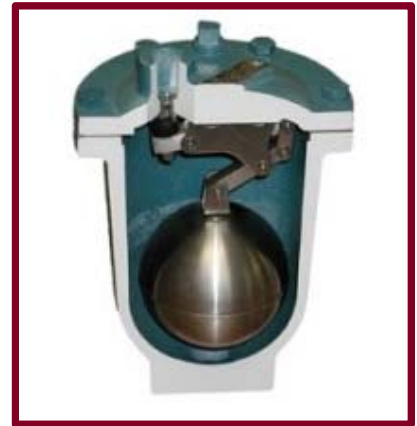
Water ARVs have not been maintained annually in accordance with best practices. As of October 16, 2017, the Utilities Maintenance Division had 240 water ARVs. ARVs are designed to protect the pipeline system and maintain its efficiency by automatically releasing small pockets of accumulated air while the pipeline operates under pressure. When air becomes trapped, it can cause pump failures, corrosion, flow issues, and water hammer or pressure surges. Unnecessary air in the pipeline also makes the pump work harder, resulting in additional energy consumption.

We performed a sample test of 50 water ARVs to determine if maintenance was performed annually. Our test results indicated that 100% of the sample had not been maintained annually. In addition, 47 of the 50 (94%) water ARVs did not have installation dates (see OFI No. 9 for further discussion). Fourteen of the 50 (28%) water ARVs indicated the ARVs were turned off or unable to be located.

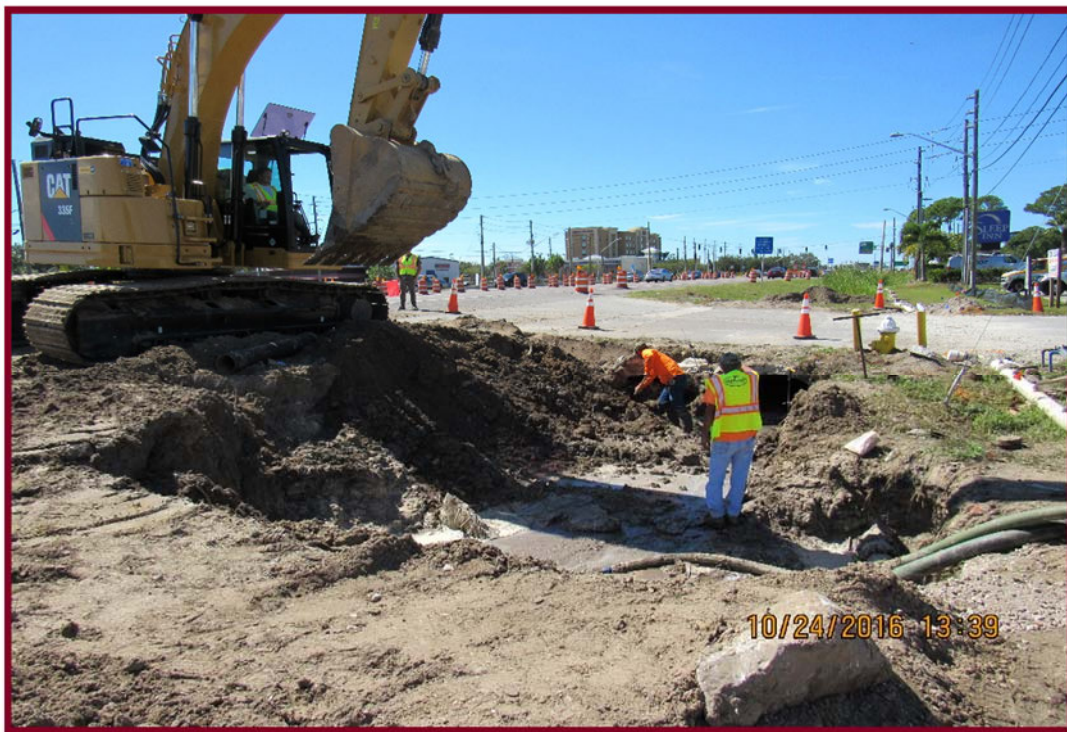
During the course of the audit, we visited project job sites, some of which included damaged utility pipes. Interviews with on-site contractors identified consistent concerns for pipes that were either not properly marked or not marked at all. During an on-site visit of a pipe break on Ulmerton Road, that was reportedly not marked at all, the contractor stated that this type of issue happens frequently.
